# Railing Replacement

Avoid Safety Issues and Future Costly Repairs Now

by Dennis Hill

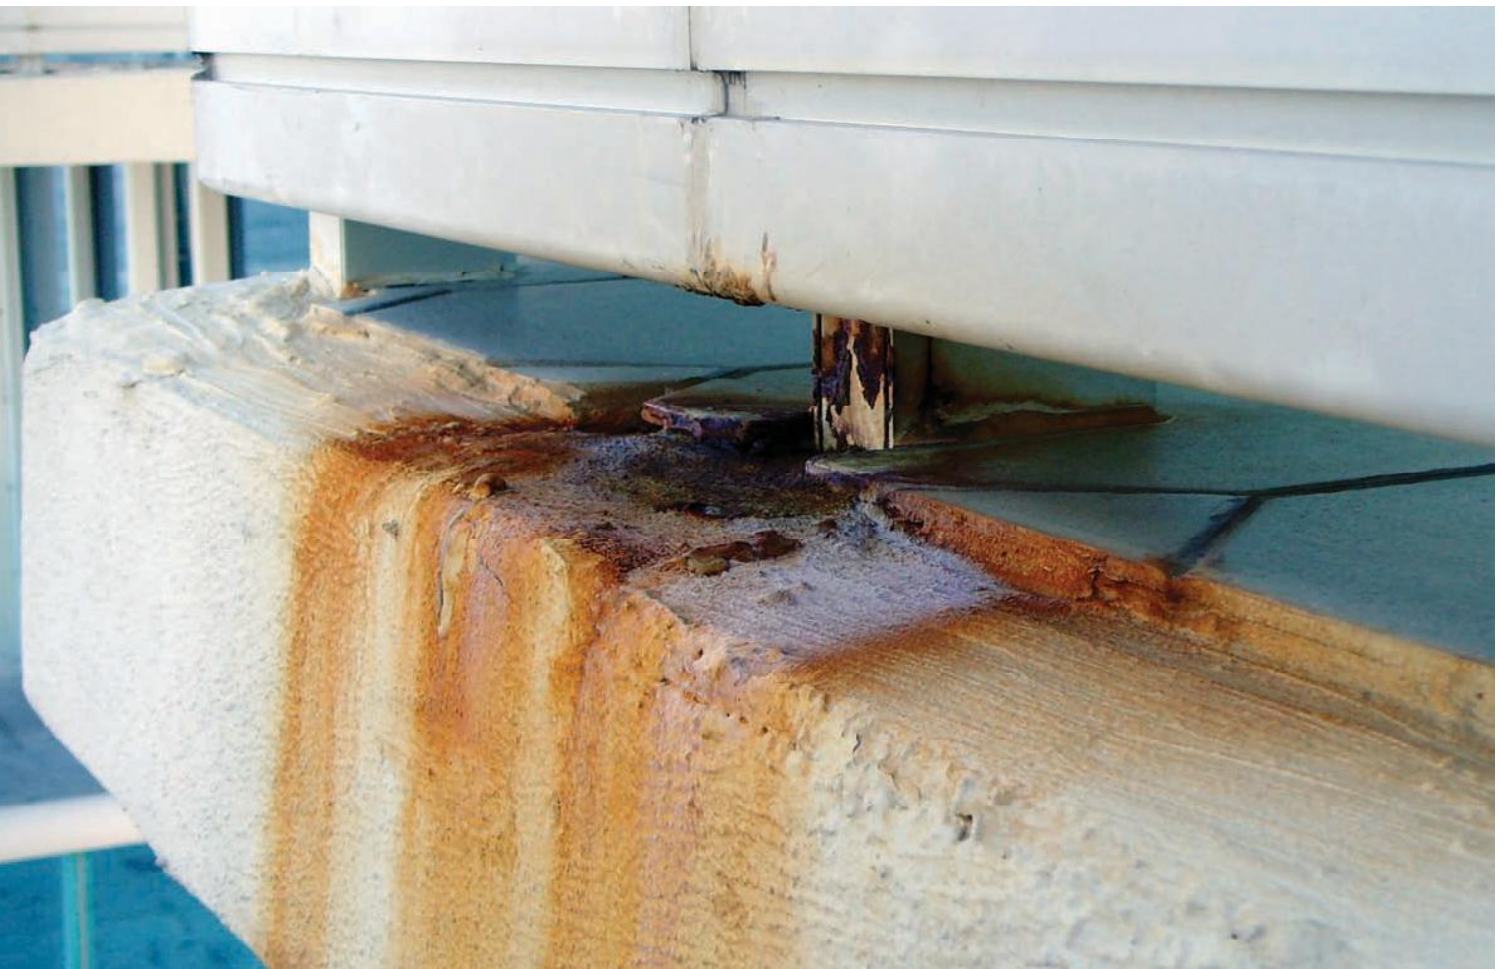
**T**he pictures tell the story. Ugly rust stains drip over the concrete balcony, cracked and broken concrete, and corroded railing posts are all too common sights in communities and high-rises in Florida, especially on or near any part of Florida's 1,197 miles of coastline. It is estimated that over \$1 billion a year is spent on restoration in the state of Florida, although there are no firm figures on railing replacement as part of that restoration.

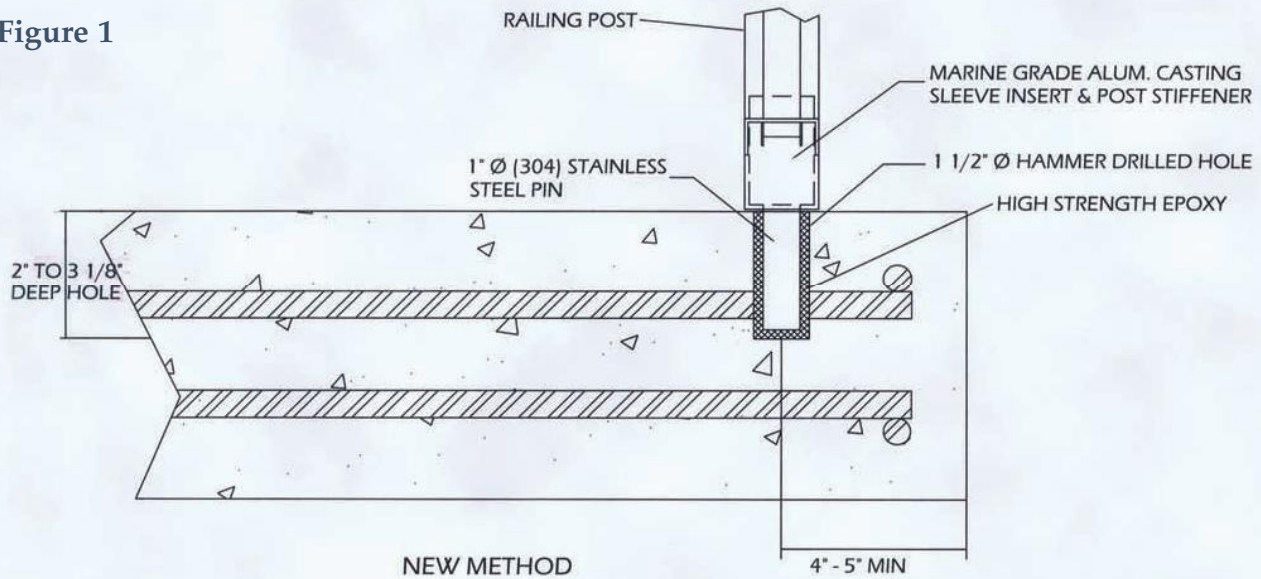
Figure 1

However, the industry has seen recent advancements in railing system installation methods. One such method uses a patent-pending system utilizing a carbon free stainless steel pin that is inserted into the railing post and set into the concrete with epoxy (See Figure 1). The epoxy waterproofs the hole, bonds to the concrete, and is electrically non-conductive preventing electrolysis.

The advantages of this system are a smaller core drilled hole; the absence of any contact between the aluminum with any cementitious material or steel; and a stainless steel pin that will never rust. Specially designed channels surrounding the insert permit condensate drainage from within the post to the surface of the concrete where it belongs.
