Understanding a Post-Tension Slab

by Richard A. Slider, P.E.

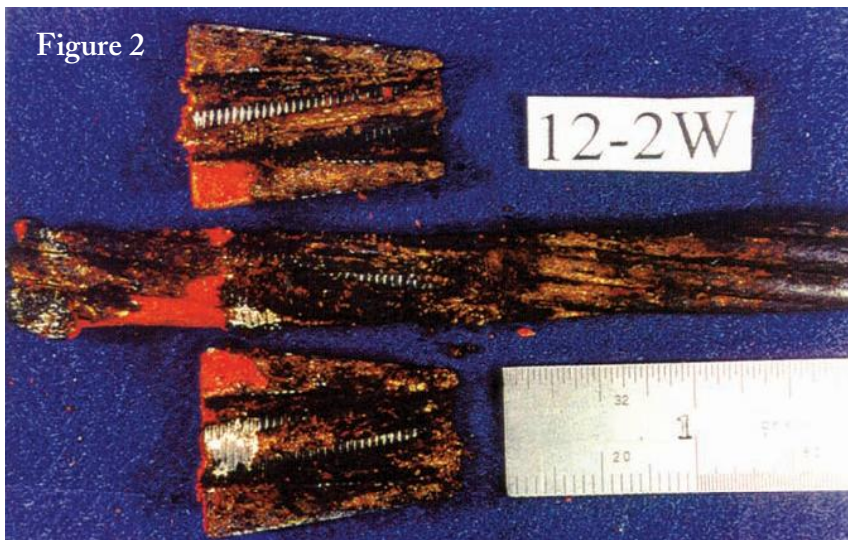
Figure 2

exposing the end anchorages for a visual observation. While corrosion on the surface of the components may be visible, the anchorage assembly may still have sufficient capacity for the intended use. In conjunction with the visual observation, samples of the anchorages are often removed and subjected to a microscopic examination to observe and measure the integrity of the teeth on the wedges and to evaluate the condition of the strand (Figure 1). The repair of the anchorage would include removal of surface rust and the application of protective coatings. Cables which have been damaged by corrosion would have to be replaced (Figure 2).

the steel anchorage and cable ends. As a result, infiltration of moisture through the concrete often results in corrosion of the post-tension cable, anchor, and wedges. The corrosion of the anchors and cables are most often identified by rust bleeding at the edge of the slab.
