Winston Trails, Lake Worth, Florida

A Case Study in Lake Restoration

by John Tight

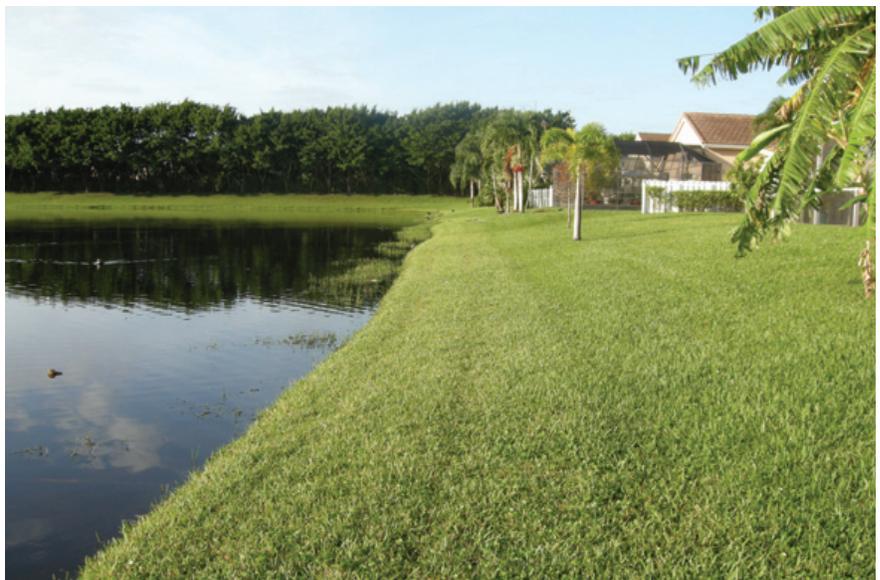
to experience problems with lake erosion in some of the 28 lakes in their community. Homeowners complained that their backyards were "shrinking" as the lake bank eroded and the shoreline moved closer to their properties. Owners also reported visible gullies, exposed drainage pipes, and unstable lake banks.

- Slopes that were too steep or likely to become too steep
- Washouts, gullies, collapsed lake banks, and unstable grounds
- Easement issues including patios, trees, and fences within 20 feet of the water's edge

Coston Marine Services was hired to complete the first phase of the project and began installing the Geo Tubes in 2008. Coston also installed drainage pipes under the Geo Tubes to capture stormwater

from the gutters that might otherwise cause future erosion. The first phase of the project was completed on budget in 2011, and a recent inspection by Civil Solutions confirmed that the Geo Tube installation should hold up for many years to come. Civil Solutions also made recommendations for changes to enhance future installations.
