# Ponding

ELIMINATING A NUISANCE AND A DANGER

BY CONNIE  
LORENZ

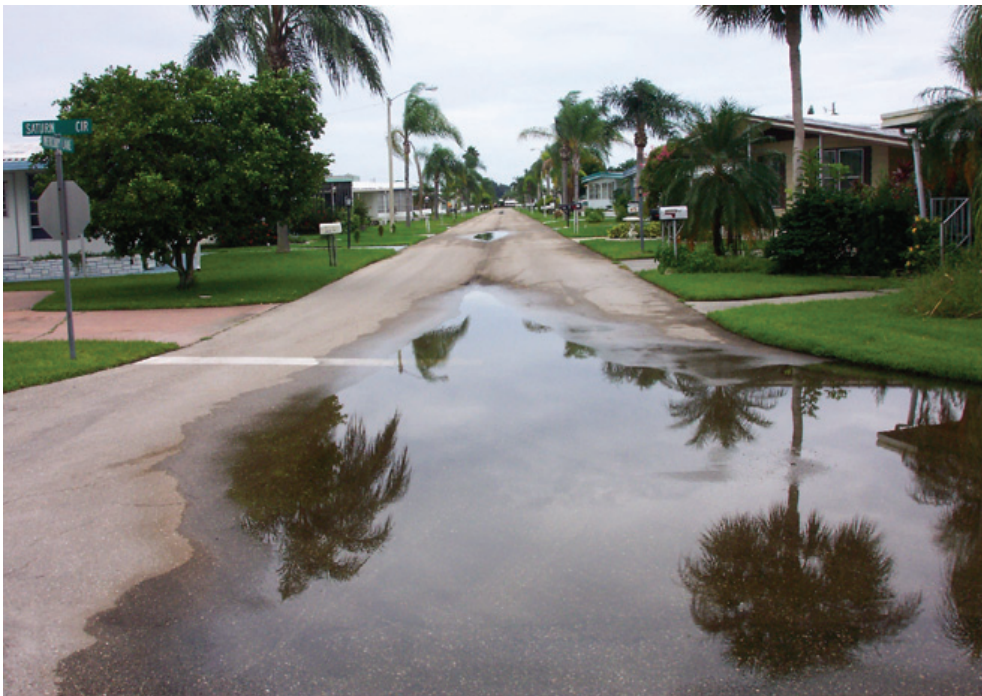
When I evaluated the area, I noticed that the water was ponding at the drain to the retention pond. Upon closer inspection, it was noticed that the gravel and dirt from the roadways and thatch buildup had created a blockage and prevented the water from draining. The board had their maintenance personnel dig out the grass in the area of the flume. The water now drains properly, and the residents are happy.

Other types of ponding are easily correctible if you know what to look for. I have a client whose residents were complaining about a large ponded area in their clubhouse parking lot. Many of the resident’s drove cars that sat closer to the ground and were complaining about water seeping into their vehicles when they drove through the puddle to the clubhouse.
